NUCLEAR SAFETY

A Quarterly Technical Progress Review

Accidental Nuclear Excursion in Recuplex Operation at Hanford in April 1962

By D. Callihan

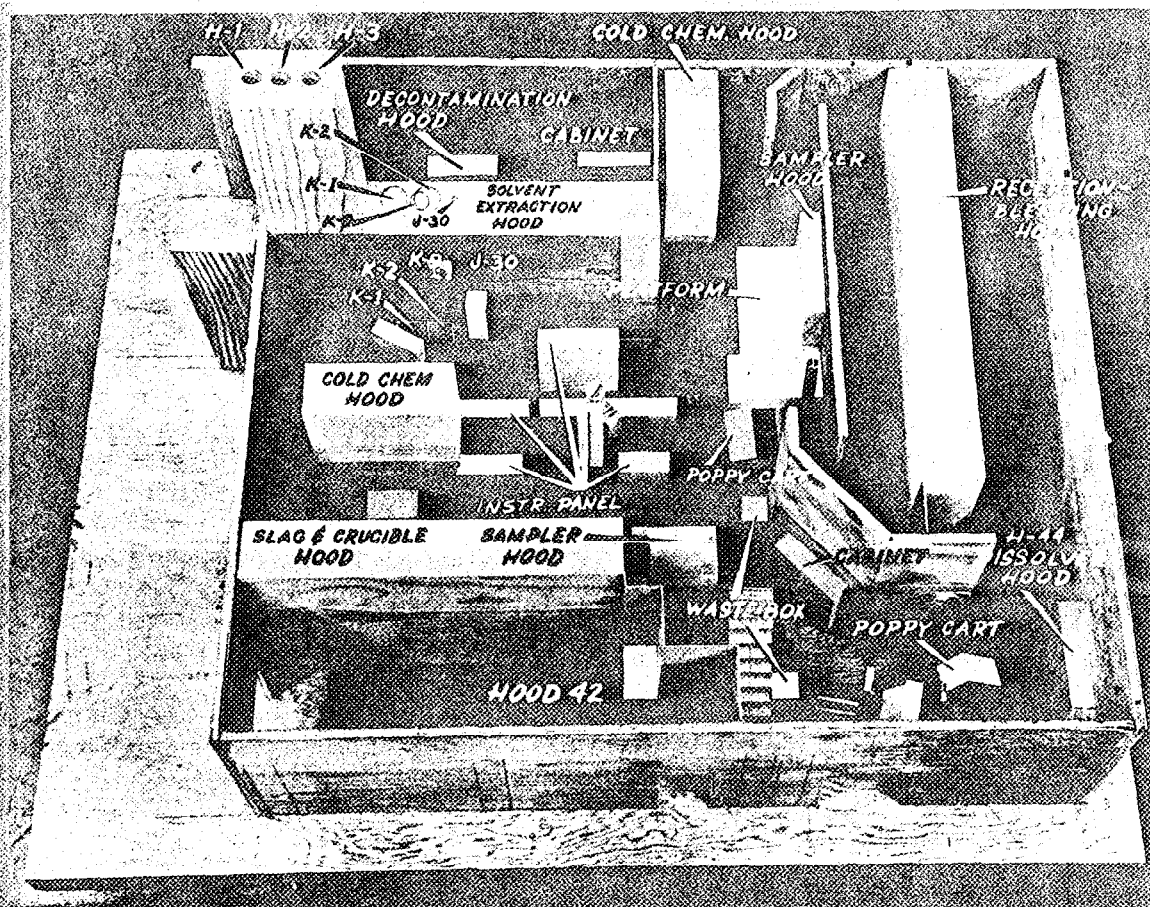
The accident occurred in a multipurpose recovery system designated Recuplex. The equipment for this operation was located, in part, in Room 221, Building 234-5, as shown in Fig. VI-4. Of the equipment in Room 221, that located in the solvent-extraction hood is more germane to the review of the accident than is any other. Figure VI-5 is a photograph of a model of the solvent-extraction hood showing the three extraction columns, H-1, H-2, and H-3; a product-receiver tank, J-1; two solvent treatment tanks, K-1 and K-2, where additional purification of the plutonium was carried out; and a solution transfer tank, K-9. Although the other equipment shown in the model is not of importance to this discussion, its presence illustrates the necessary complexity of the equipment layout. One additional vessel, a waste receiver tank designated L-2, located in the reception and blending hood (Fig. VI-4) is referred to in this review. In this recovery system, plutonium was being salvaged from various waste streams arising both within the Hanford production complex and in off-site sources. The impurities from which the plu-

Fig. VI-4 Model of hood arrangement in Room 221 (Fig. IV-2 of Ref. 14 with additions to show positions of solvent-extraction columns H-1, H-2, and H-3 of Fig. VI-6).

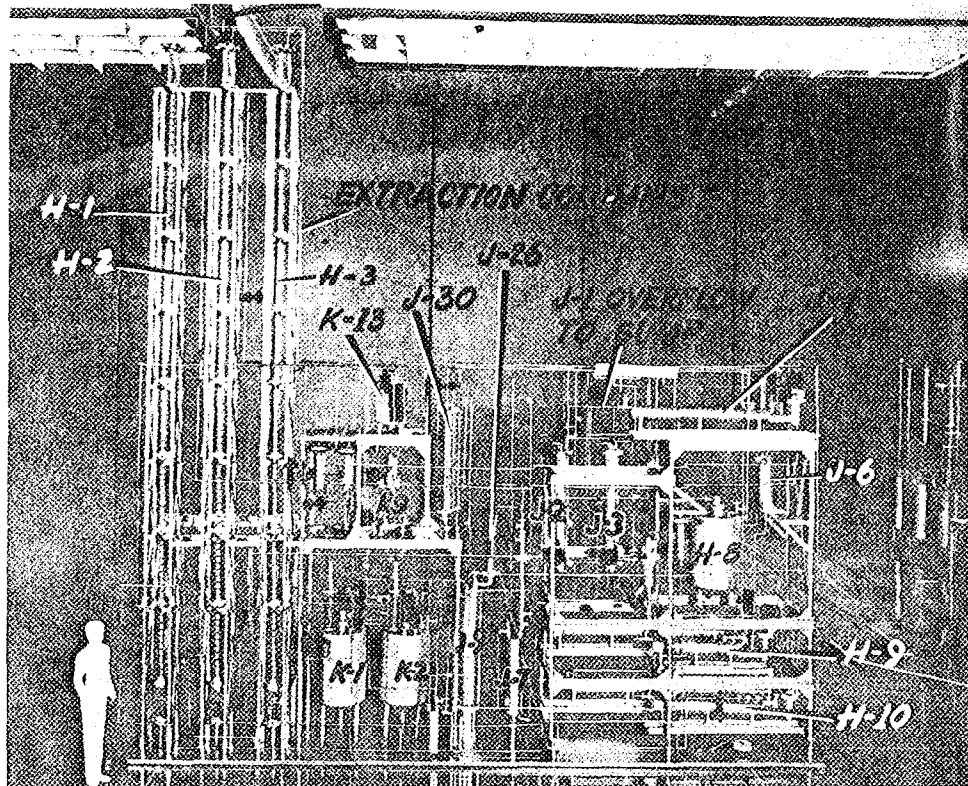
Fig. VI-5 Model of SE hood.

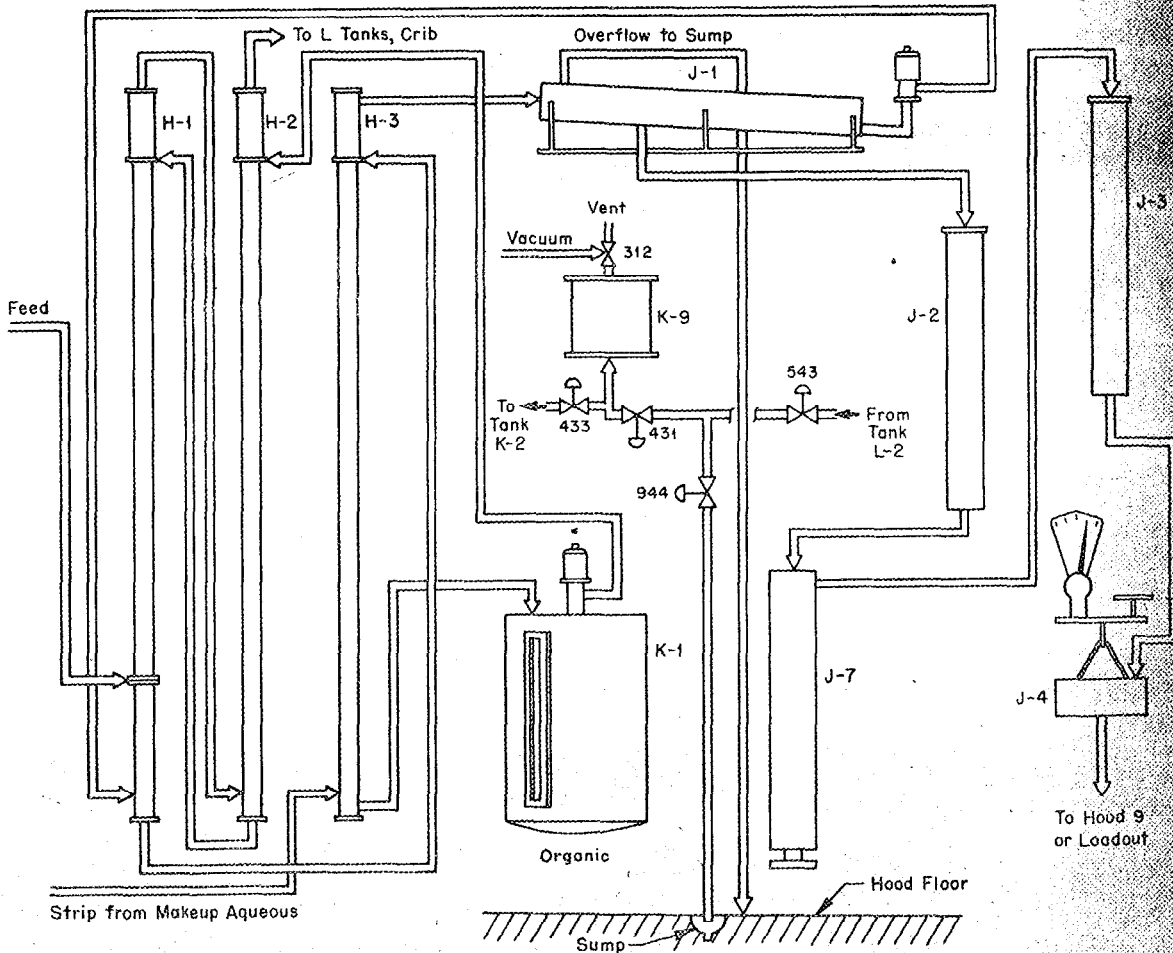
Fig. VI-6. Flow diagram of solvent-extraction process (Fig. IV-5 of Ref. 14 with additions to show

Mention has been made of the continued presence of the plastic tube, which was temporarily installed for the hood cleanup, and of the fact that one of the two valves (valve 431 in Fig. VI-6) separating the tube from tank K-9 was found open after the accident. The end of the tube was located in the floor sump. The one valve (944) found closed after the accident must have been opened, at least momentarily, to substantiate the most reasonable reconstruction of the accident. No evidence of the valve being opened was presented by operating personnel. The valve was of a ball-plug type requiring only a 90° turn of a bar handle from full open to full closed. The handle was inside the glove box, and an accidental turn of it while manipulating another was unlikely but possible.

When reentry of the area was made, tank K-9 was found vented to the atmosphere, a consequence, no doubt, of remote manipulation of the three-way (vent vacuum K-9) valve (312) during the activities whereby the safety of reentry was assured. There is little question that tank K-9 was under vacuum at the time of the accident. Therefore a plausible path and means of movement of the solution existed.
